Annual Inspection Report

St. Clair County Airport

ANNUAL INSPECTION REPORT

JANUARY 19, 2011

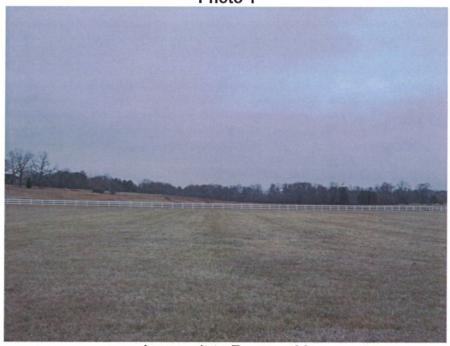
- → The 20:1 slope required for the Approach/Departure Path of Runway 3 is violated by a road. The threshold is displaced 50 to provide the proper clearance over the road.
- → The Approach/Departure Path of Runway 21 is free of obstructions.

Approach to Runway 03

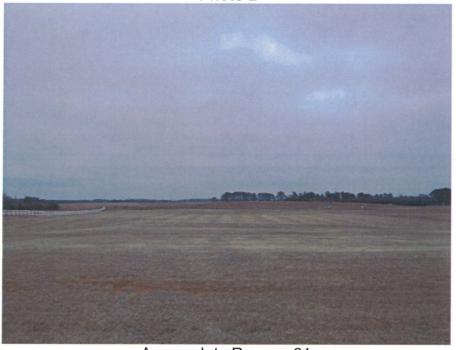
Photo 2

Approach to Runway 21

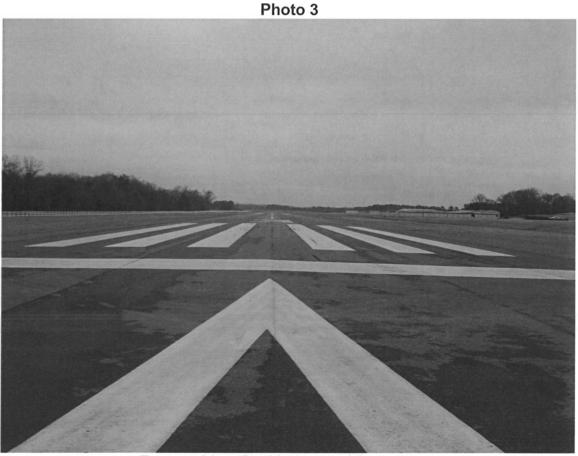
Runway Identifier Markings of Runway 03

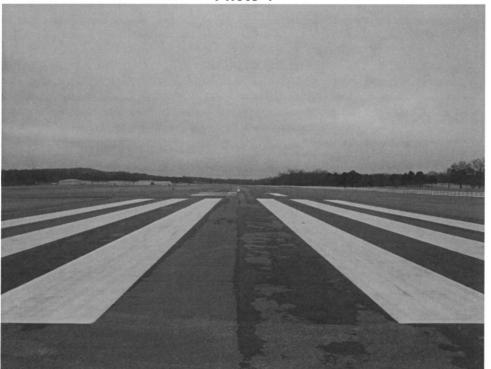
Runway Identifier Markings of Runway 21

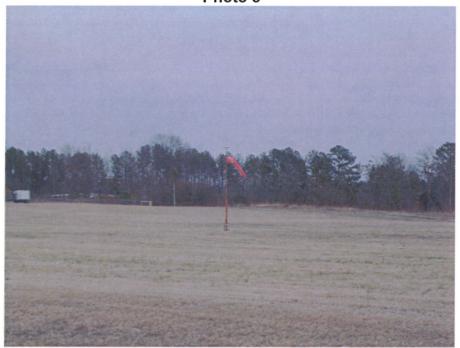
→ The wind direction indicator was inspected and found to be lit and operational.

Windsock Assembly

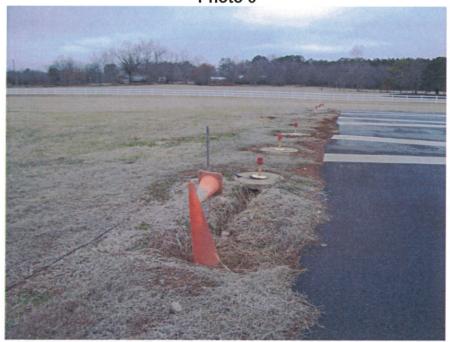
- → The airport lighting was found to have wiring to the threshold fixtures run along the ground to supply electrical current to the fixtures. The wiring was run from the nearest taxiway lighting fixture.
- → The lighting was operational by radio control and all lighting on the runway and taxiway were operational.
- → The design of a new lighting system to replace the existing lighting system is being developed.

Threshold lighting at Runway 3

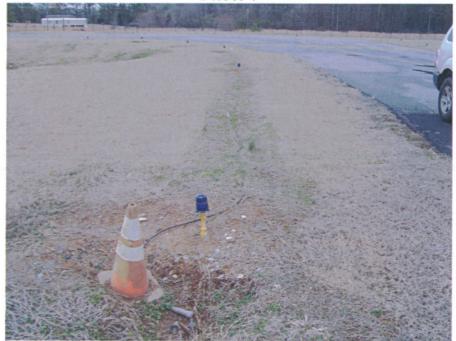
Photo 7

Wiring run from taxiway fixture to threshold of Runway 3

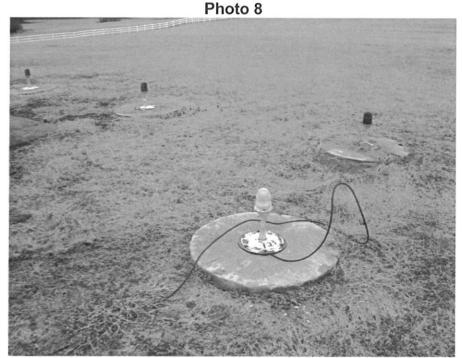
Above ground wiring at the threshold of Runway 21

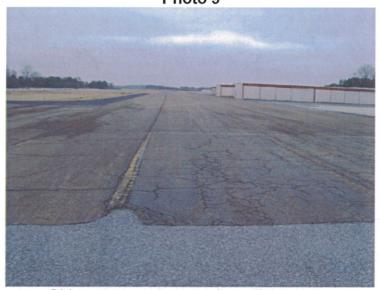
The runway and ramp areas are in good to excellent condition with the older portion of the parallel taxiway only in fair condition, due to moderate raveling and cracking.

Old pavement section of parallel taxiway

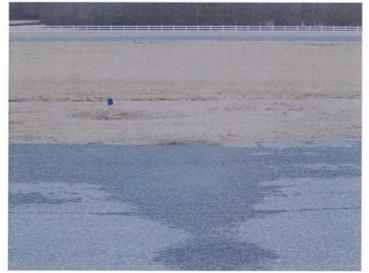
Photo 10

- → The pavement over the drainage pipes across the new taxiway section has dropped creating a dip in these two areas. This condition creates a hazard for aircraft with a short propeller clearance from the ground.
- → There is an erosion problem at several areas along the runway and taxiways.
- → Water is draining to the intersection of Taxiway B and standing.

Dip in pavement along new pavement section of parallel taxiway holding water

- Repair the dips in the taxiway due to settlement over the drainage pipes from the new apron.
- → Develop plans to correct the drainage between the runway and taxiway.
- → Develop plans to replace the drainage structures under the runway and taxiways.
- → Repair the eroded areas along the taxiways.

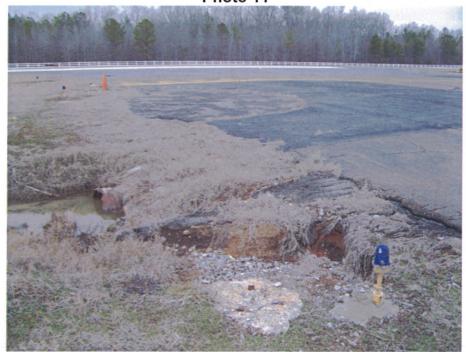
Erosion and standing water at the Taxiway B intersection (Inlet end)

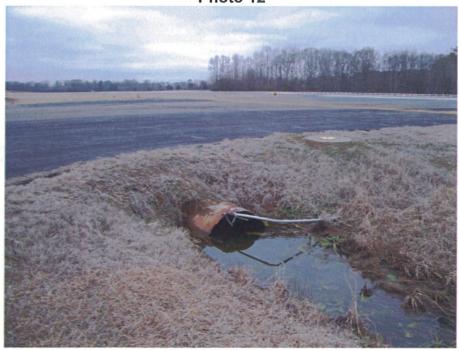
Photo 12

Outlet end of same pipe

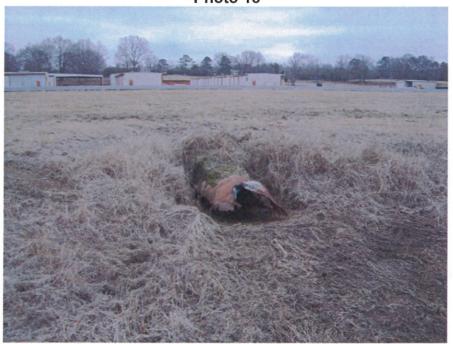
Photo 13

Outlet end of drain across runway

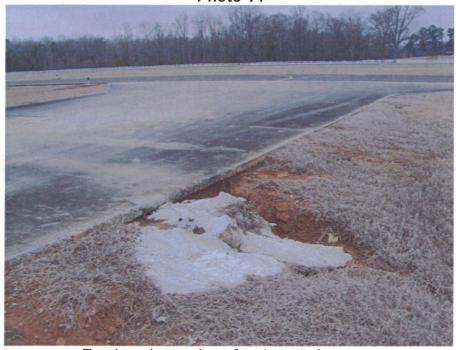
Photo 14

Erosion along edge of taxiway to hangars
